## **GUIDE TO VOLUME IV-D**

## **Ground Vibration at Mayo Clinic Magnetic Resonance Imaging Systems**

**GROUND VIBRATION AT MAYO CLINIC  
MAGNETIC RESONANCE IMAGING SYSTEMS**

14 August 2001

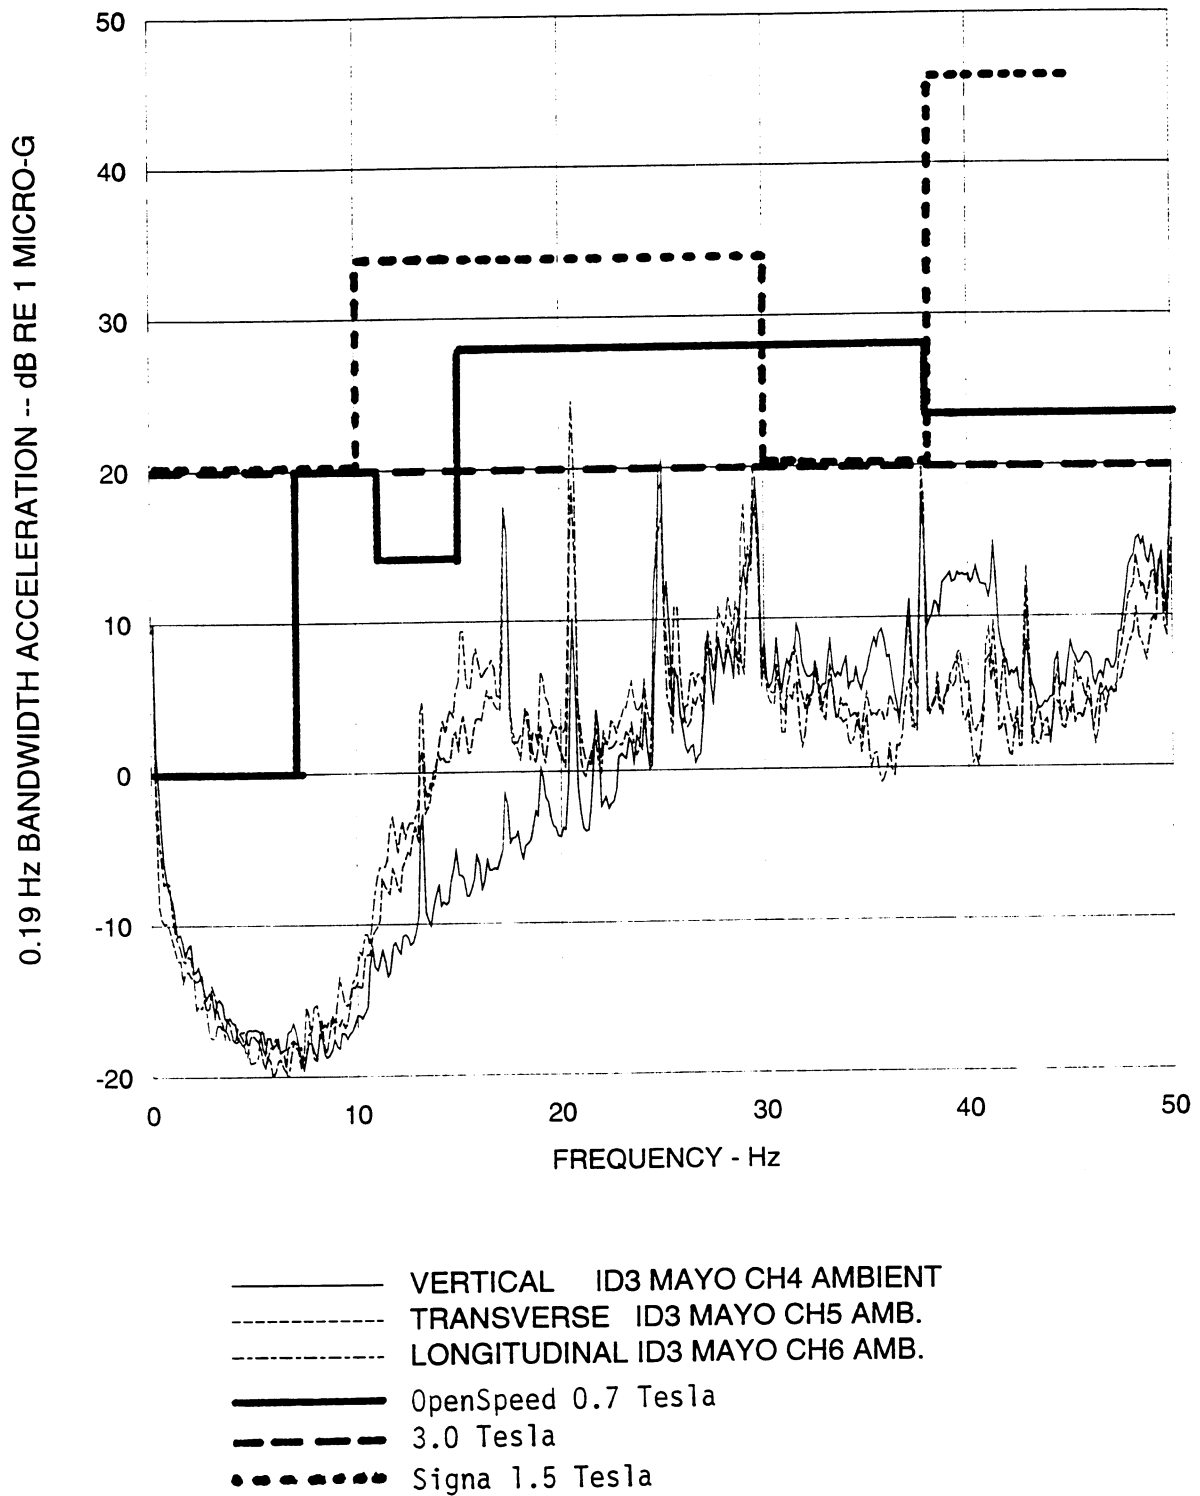
FIGURE 2A AMBIENT GROUND VIBRATION ON SOIL AT PROPOSED MRI SITE  
AT MAYO CLINIC

Ground vibration spectra obtained at Location 1 are presented in Figures 2A through 2C. Figure 2A is of ambient ground vibration. The discrete frequency components shown in the spectra are probably caused by rotating or reciprocating mechanical equipment, though the specific sources were not identified. Figures 1B and 1C illustrate the ground vibration recorded during the eastbound and westbound train passes, respectively. The data obtained for the trains are very similar to the ambient ground vibration, though the train vibration is higher than the ambient from about 5 Hz to 25 Hz, neglecting the discrete frequency components caused by the mechanical equipment. Corresponding data measured at Location 2 are presented in Figures 3A, 3B, and 3C. The train vibration at Location 3A exceeds the ambient ground vibration by roughly 10 decibels at frequencies below 10 Hz.

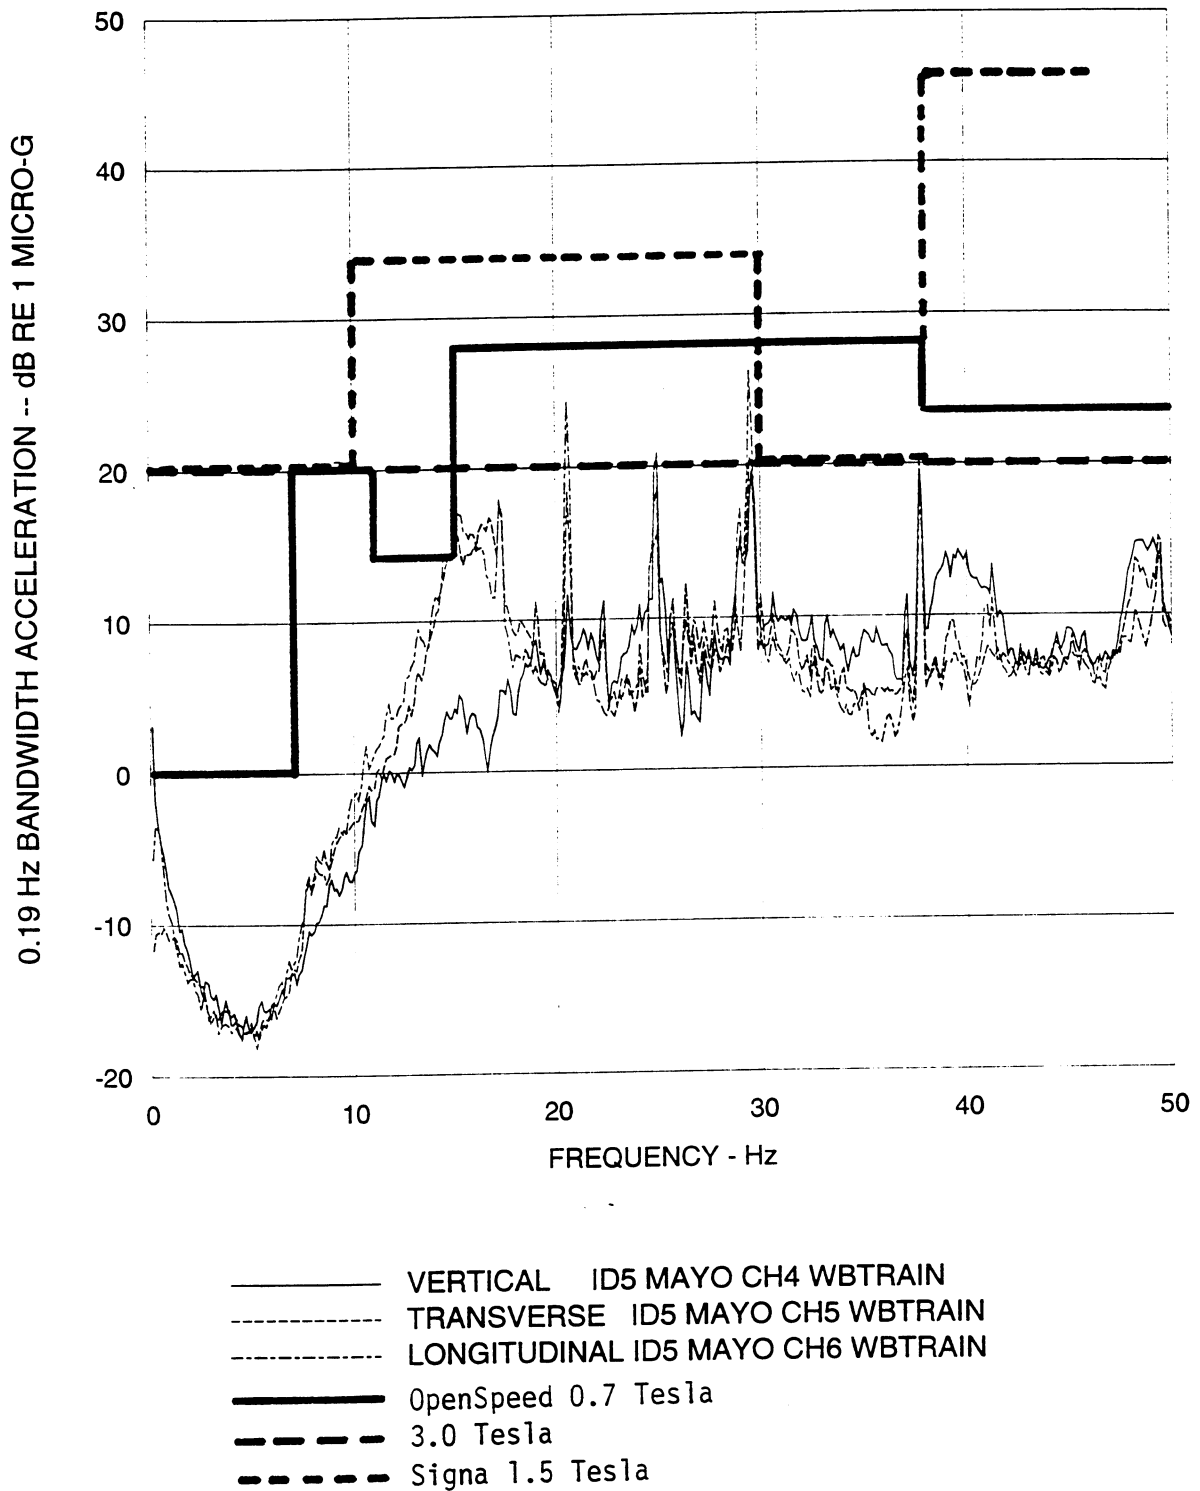
FIGURE 2B WESTBOUND TRAIN GROUND VIBRATION ON SOIL AT PROPOSED MRI MAYO CLINIC

The existing ground vibration spectra observed for the eastbound and westbound trains indicate a broad peak between about 14 and 18 Hz. The amplitude and frequency of this peak will likely shift upward with increasing train speeds. The vibration at Location 1 would likely remain within the specification for the 0.7 Tesla MRI, but might exceed the limit given for the 3.0 Tesla MRI, not with standing the beneficial effects of continuous welded rail. At Location 2, the vibration would likely remain within both specifications. None of the project vibration would likely exceed the specification for the 1.5 Tesla machines shown in the figures.

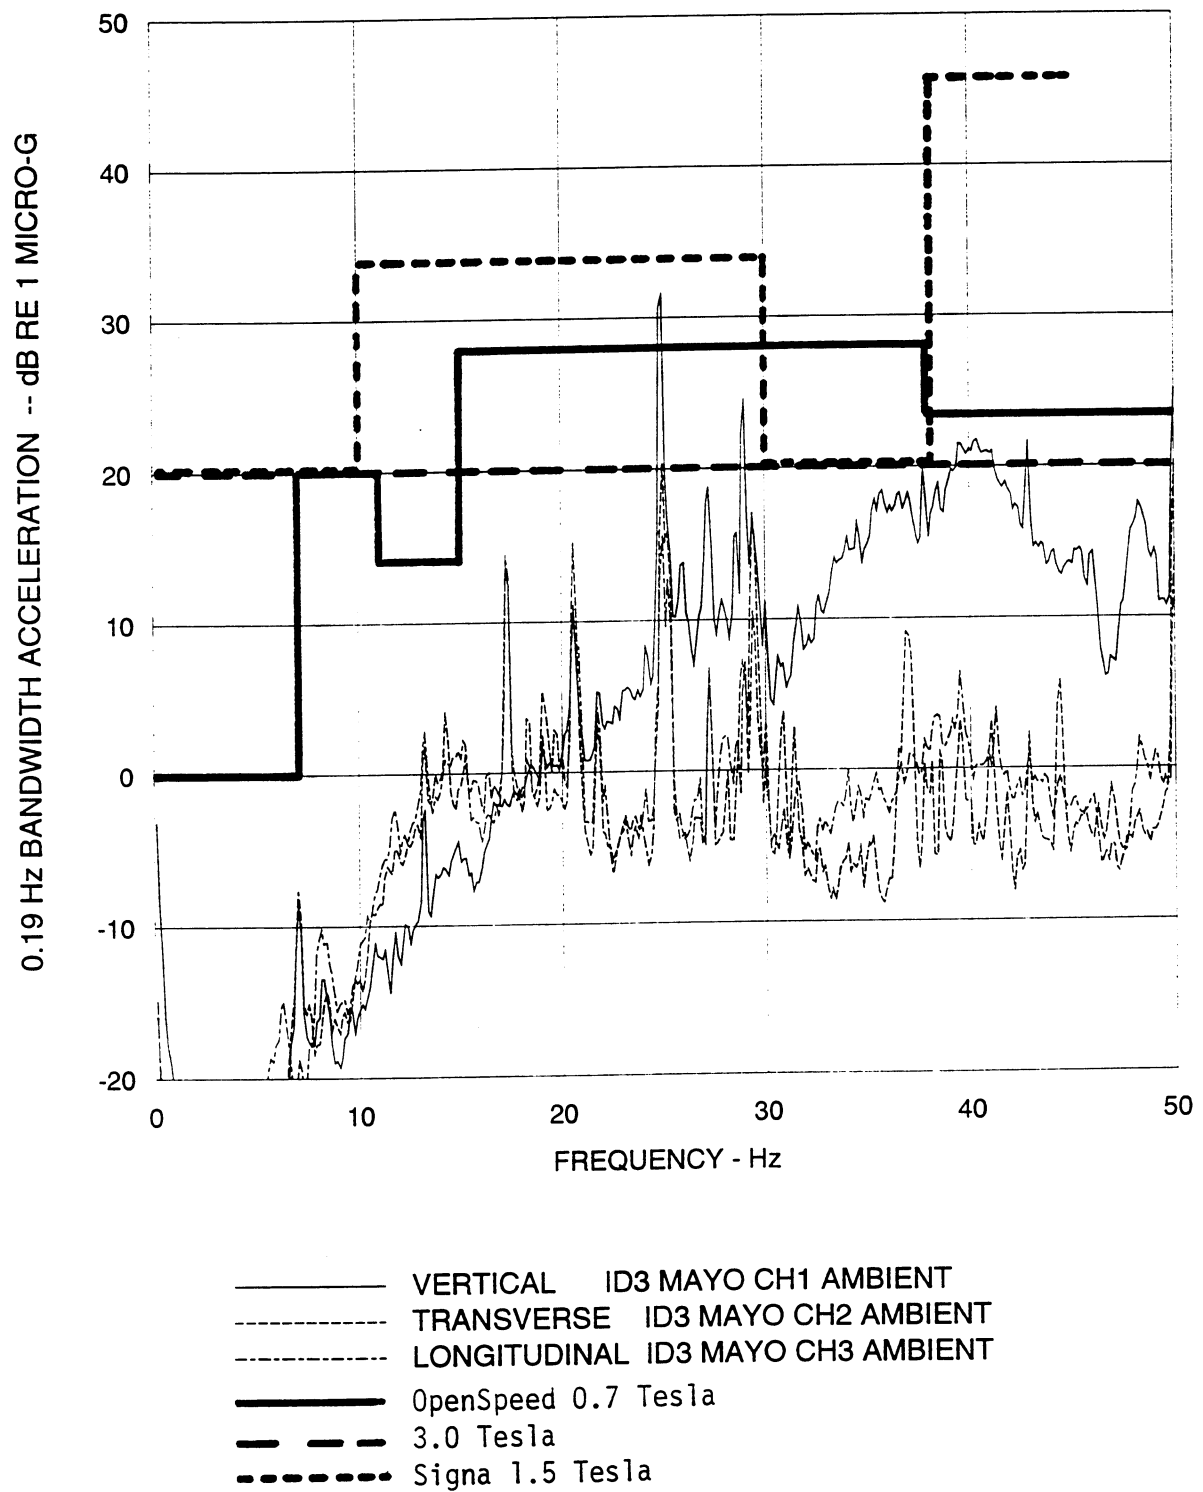
FIGURE 3A AMBIENT GROUND VIBRATION ON CONCRETE SLAB NEAR EXISTING MRI AT MAYO CLINIC

Specifications for various GE MRI's are also plotted in Figures 2A, 2B, 2C, 3A, 3B, and 3C. The most restrictive specification is the one shown for the 0.7 Tesla MRI, while the least restrictive specification is one that was applied in 1998 to GE 1.5 Tesla MRI's. The intermediate specification is for the 3.0 Tesla MRI that may or may not be installed at the Mayo Clinic. The ambient vibration data were within the specifications, except for discrete frequency components that are likely due to mechanical equipment within the building. The train vibration data appear to be within the specifications. The discrete frequency components observed during train passage were related to those appearing during the ambient samples, and are thus not attributed to the trains. For example, during passage of the eastbound train, an additional discrete frequency component was observed at about 27 Hz, and as shown in Figures 2A and 3A. This component is in excess of the specifications, but is not due to the train. The component appears in the background data obtained at Location 2, as shown in Figure 3A.

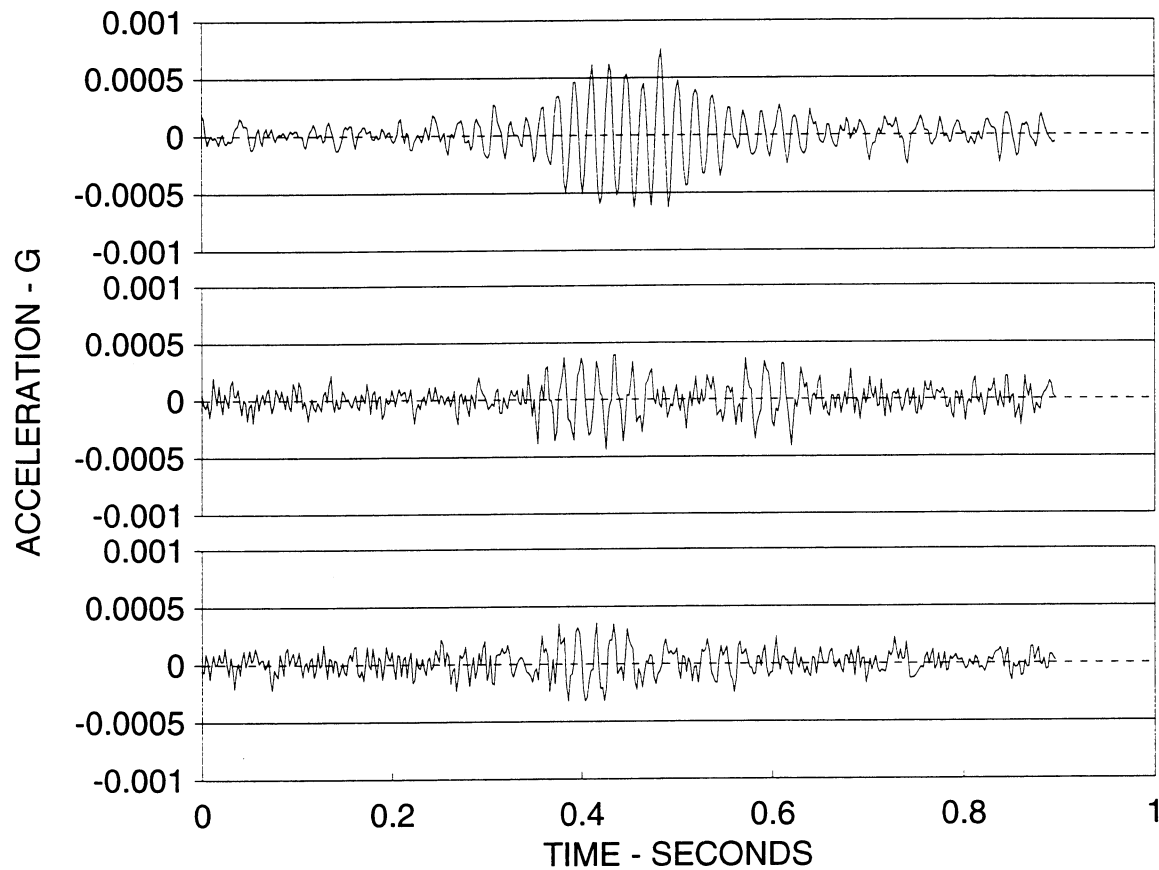
**Figure 4**      **Ground Vibration Transient at Location 1 during Passage of Westbound Train**

Transient vibration data collected during the westbound unloaded train are presented in Figures 4 and 5 for Locations 1 and 2, respectively. The vertical, transverse, and longitudinal directions are represented. The transient data are for a single event, and are believed to be caused by slack action of the train. At Location 1, the maximum magnitude of vertical acceleration was about 700 micro-g. At Location 2, the maximum magnitude of vertical acceleration was between 1,300 and 1,500 micro-g. The horizontal components of vibration were within the 500 micro-g limit at both locations.

Ground vibration produced, apparently, by slack action of the westbound train during braking was in excess of the transient acceleration limit of 500 micro-g. This was the only identifiable event that appeared to be in excess of the site specification for GE MRI's. This type of event may be a common occurrence in Rochester under present rail operations.

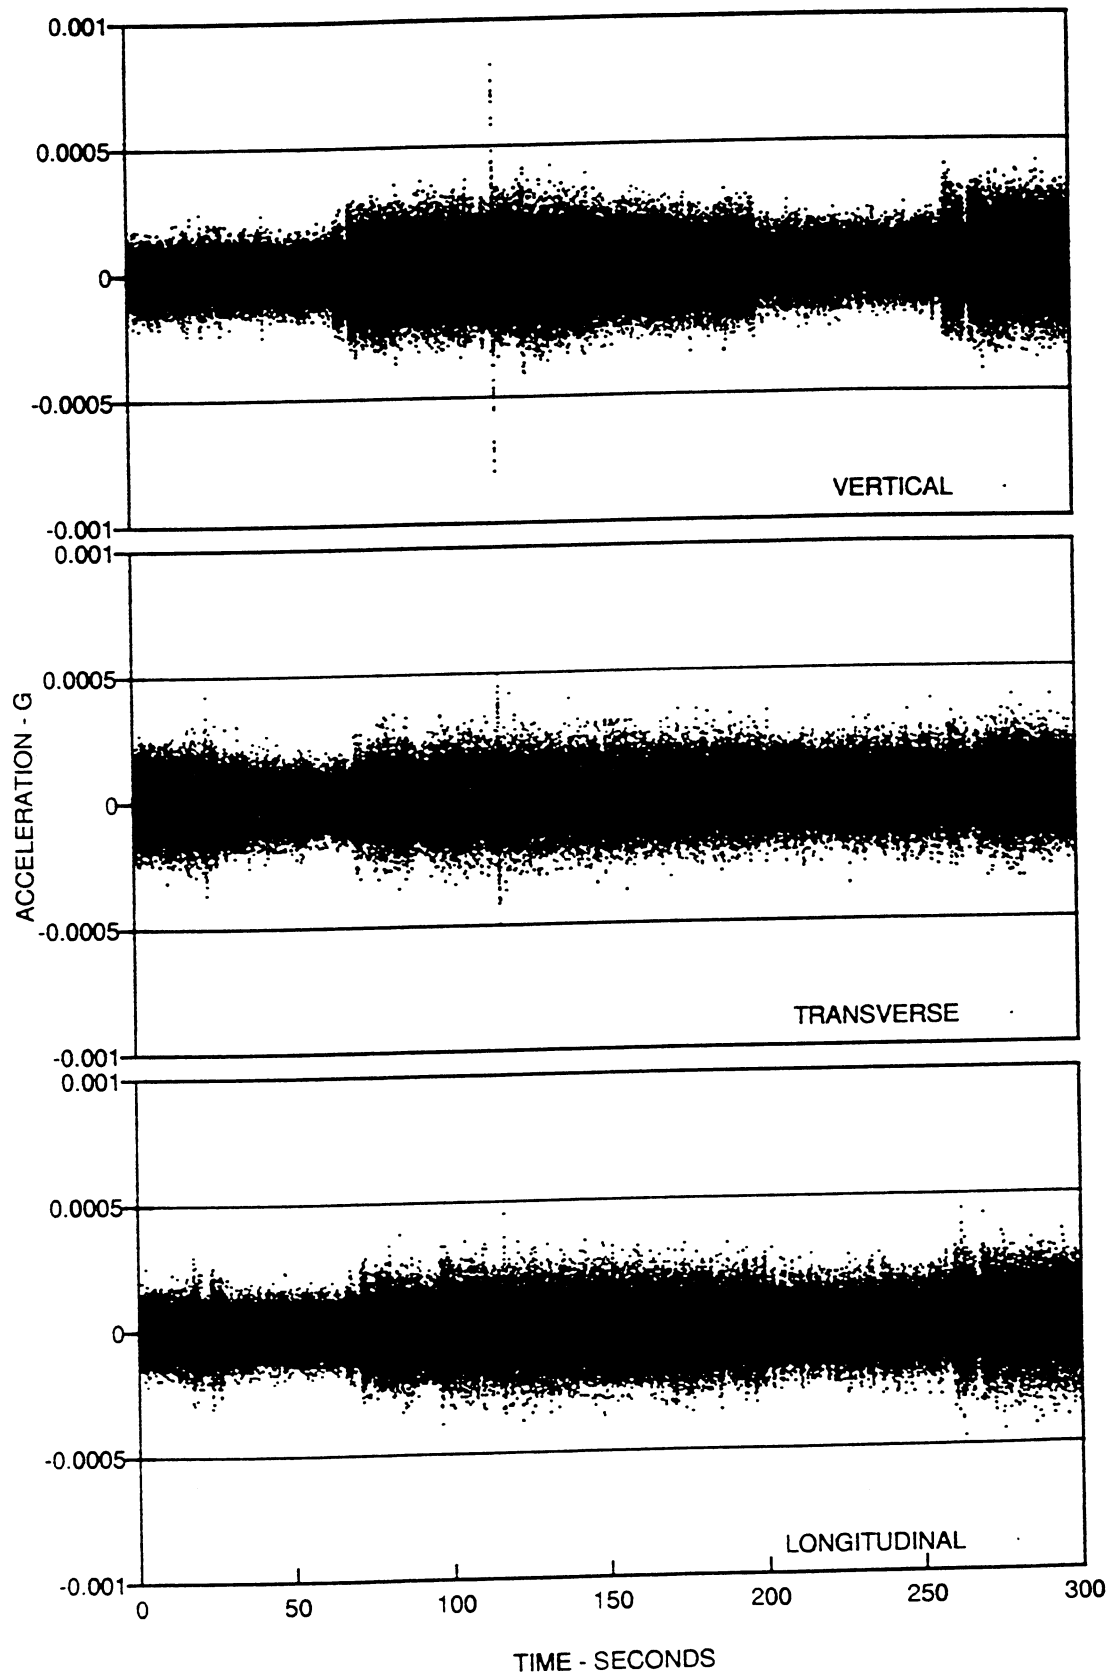
FIGURE 6A AMBIENT GROUND ACCELERATION VS TIME AT LOCATION 1

Time domain acceleration data collected at Location 1 over periods of 30 seconds are plotted in Figures 6A and 6B for the ambient and passing eastbound train conditions. These data were obtained simultaneously with the data collected at the slab at Location 2. Except for a short transient event, the ambient acceleration magnitudes were within the plus and minus 500 micro-g limits.

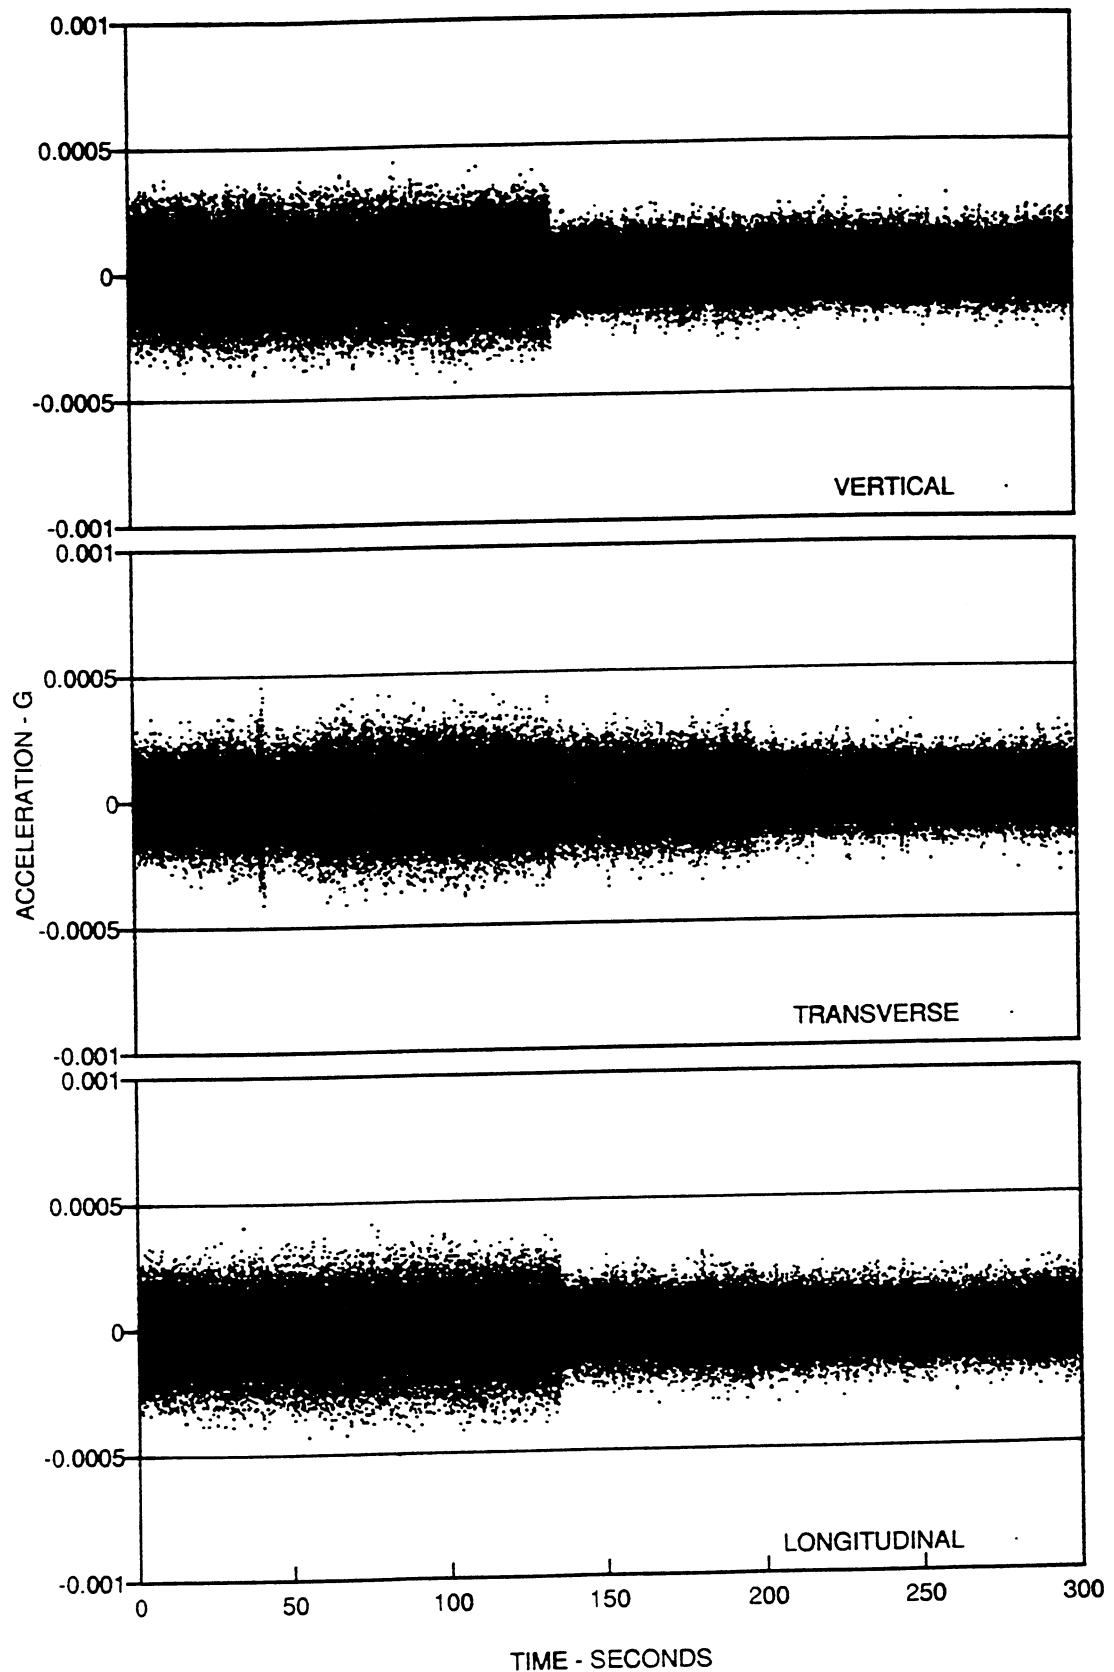
**FIGURE 6B GROUND ACCELERATION VS TIME AT LOCATION DURING EASTBOUND TRAIN PASSAGE**

During train passage, the acceleration magnitudes shown in Figure 6B were within the plus or minus 500 micro-g limits. At about 140 seconds into the sample, the vibration magnitude drops suddenly, thereafter remaining constant. The higher level occurring at the beginning of the sample is similar to the magnitudes occurring during the end of the preceding ambient sample. The train vibration sample was begun at about the same time as when the train reached the grade crossing nearest the measurement location. The passby duration is estimated to be 318 seconds, assuming a car length of 60 feet for all 67 cars and 3 locomotives traveling at 9 mph. Thus, the drop in magnitude at 130 to

140 seconds into the sample is not explained by train vibration cessation, and may be due to cessation of some piece of mechanical equipment in the building. Regardless, the train vibration data were not in excess of the limits.

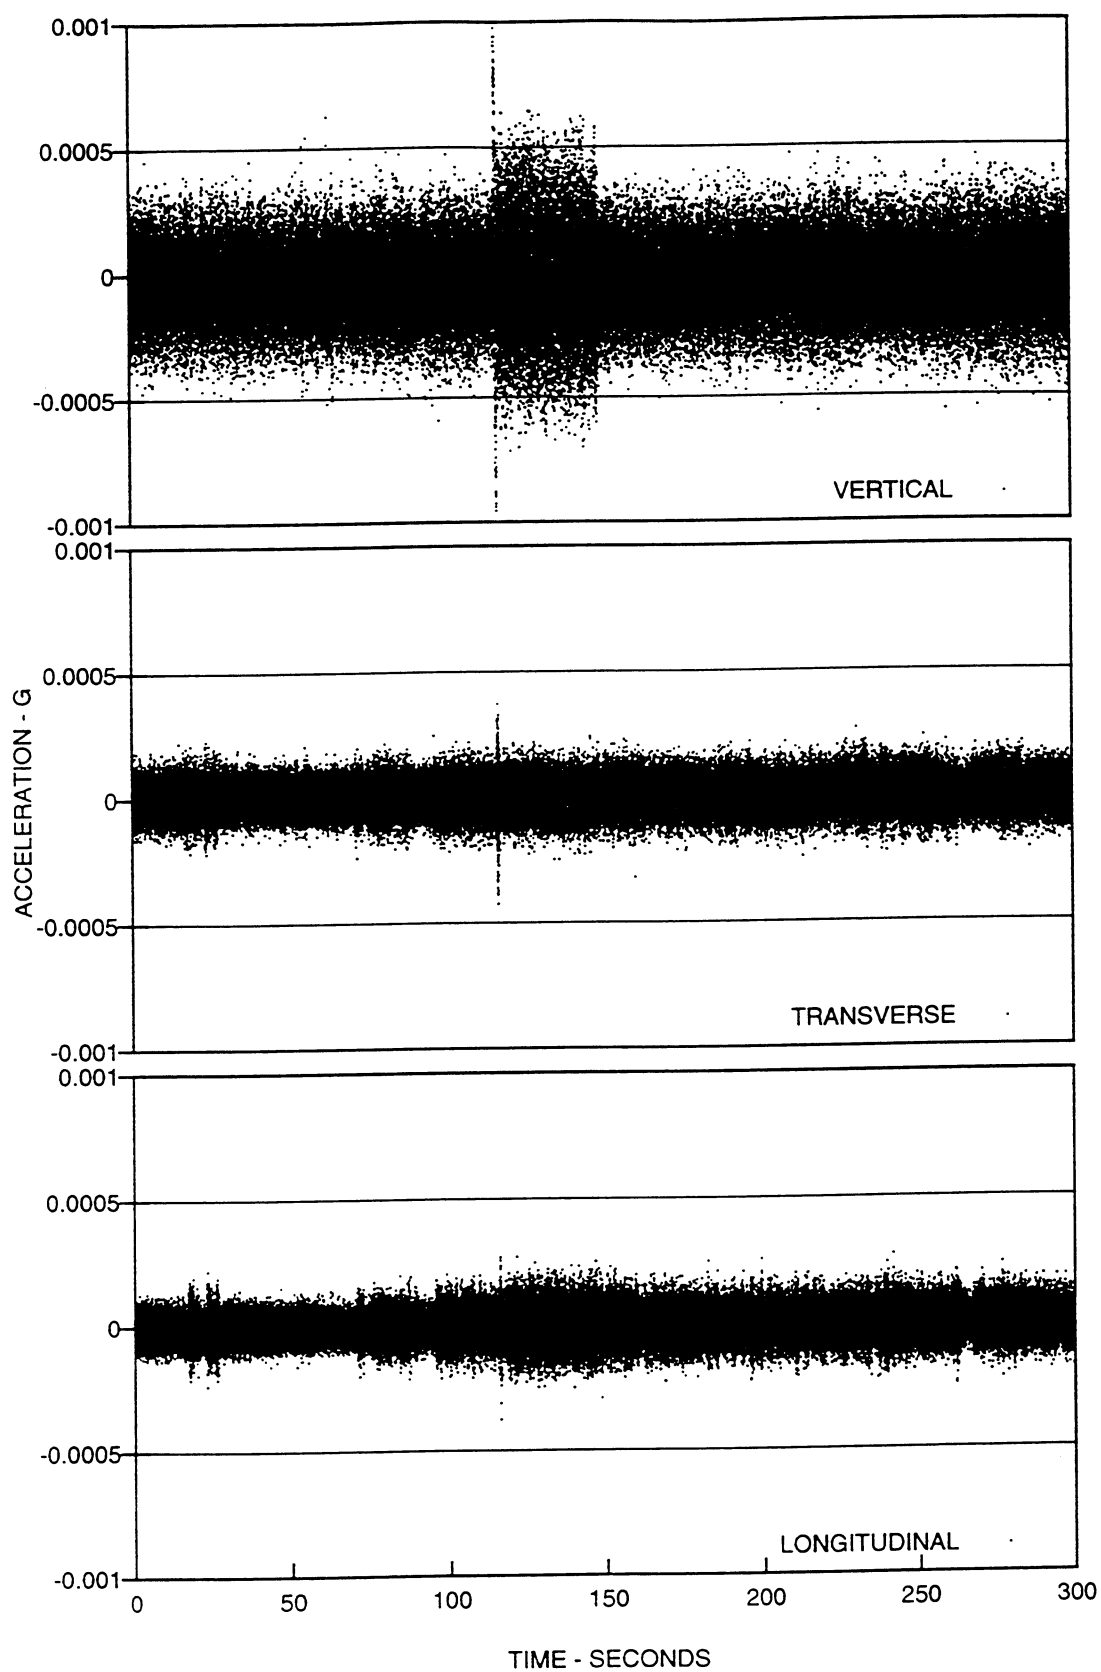
FIGURE 7A AMBIENT FLOOR SLAB ACCELERATION AT LOCATION 2

Time domain acceleration data collected at Location 2 are plotted in Figures 7A and 7B for the ambient condition prior to arrival of the loaded eastbound freight, and during passage of the loaded eastbound freight, respectively. This location was at the concrete slab. The vertical component of vibration was significantly greater than the horizontal components. These ambient data contain samples that exceeded the 500 micro-g limits, but then only relatively infrequently. During the middle of the ambient sample, a piece of mechanical equipment produced increased levels of vertical vibration for approximately 30 seconds. Also, at the beginning of the increased ambient vibration, a short duration transient produced an acceleration with magnitude of approximately 1,000 micro-g in the vertical direction, and lesser magnitudes in the horizontal direction. The same short transient acceleration occurs at about 110 seconds into the ambient sample that was observed at Location 1 and presented in Figure 6A.

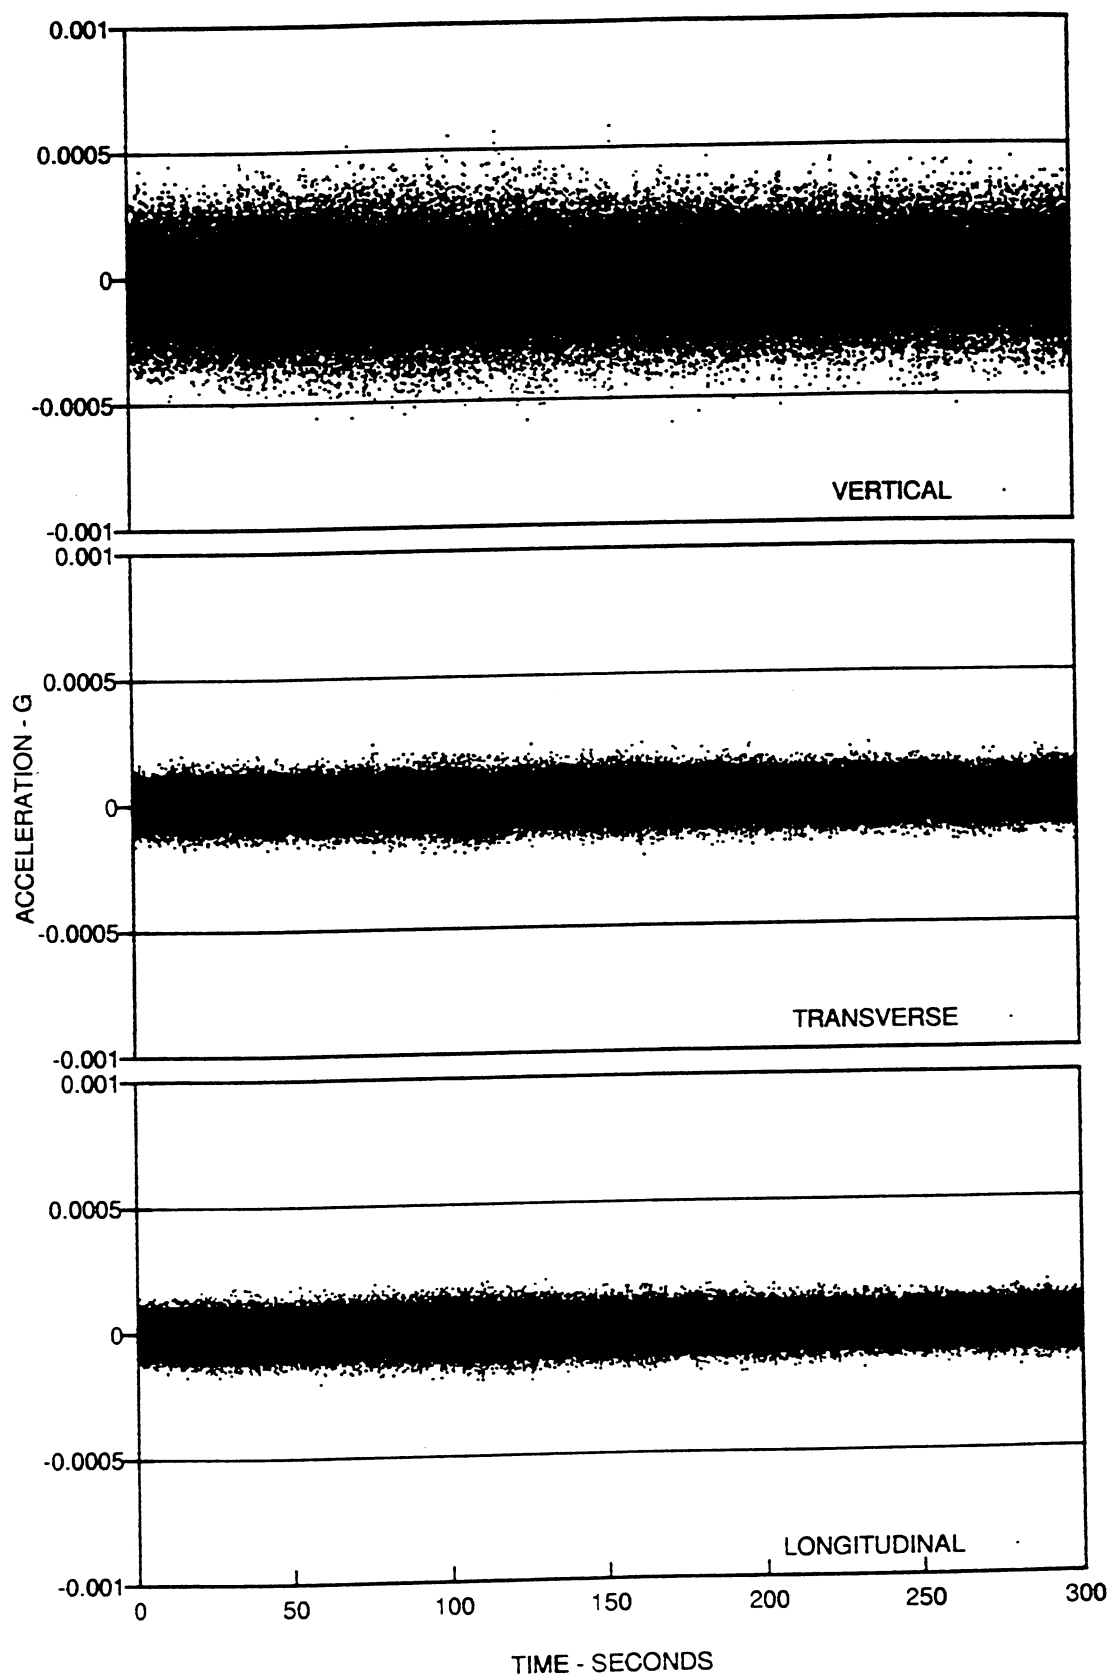
**FIGURE 7B FLOOR SLAB ACCELERATION AT LOCATION 2 DURING EASTBOUND TRAIN PASSAGE**

During train passage, the vibration data collected at Location 2 were steady. There was some evidence of vibration transients exceeding 500 micro-g during passage, but the number of exceedances is not significantly different from that of the ambient sample obtained without the anomalous building vibration.
